Manhole Inspection Summary

Manhole # S39A__025MH

Insp Date: **11/27/07 11:17 AM**

Location Address: **forrest st**

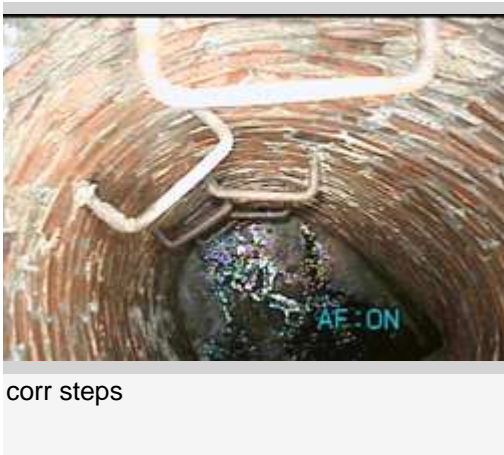
Defect 3

Count: **7** Missing: **0** ☒ **Corroded**

corr steps

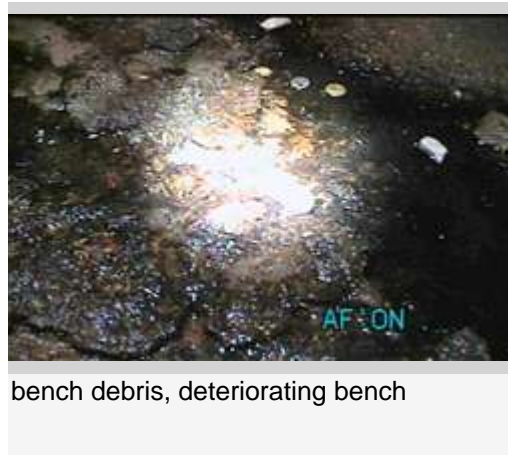
Defect 2

Condition: ☐ Sound ☐ Cracked ☐ Root Intrusion ☒ **Deteriorated** ☐ Leaks ☒ **Debris**

bench debris, deteriorating bench

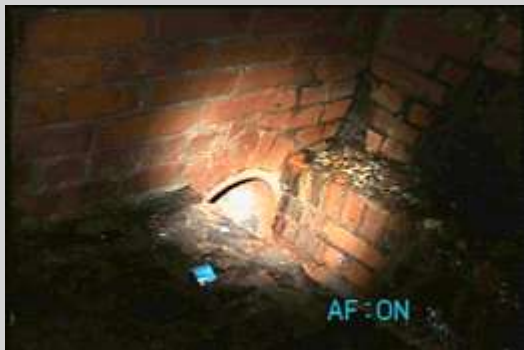
12 O'Clock Outflow

Deposits: ☐ None ☐ Mud ☐ Sludge ☒ Debris ☐ Grease

Silt Depth: 4 (in.) Deposits Extent: Medium

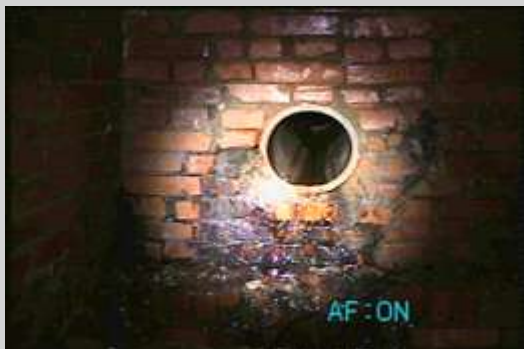
3 O'Clock Inflow

best shot camera cant get close to pipe do to shelf

Deposits: ☐ None ☐ Mud ☐ Sludge ☒ Debris ☐ Grease

Silt Depth: 4 (in.) Deposits Extent: Medium

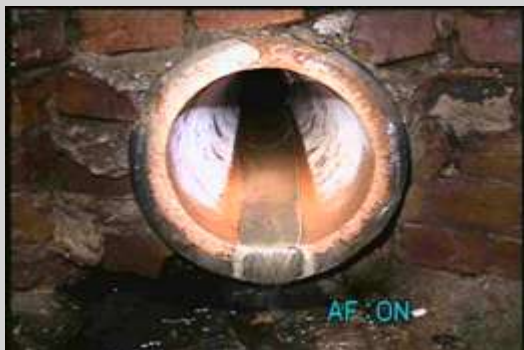
8 O'Clock Inflow

Deposits: ☐ None ☐ Mud ☐ Sludge ☒ **Debris** ☐ Grease

Silt Depth: 4 (in.) Deposits Extent: **Medium**
